STREAM CHANNEL STABILITY ASSESSMENT

January 1982
Final Report

U.S. Department of Transportation
Federal Highway Administration

Offices of Research & Development
Environmental Division
Washington, D.C. 20590

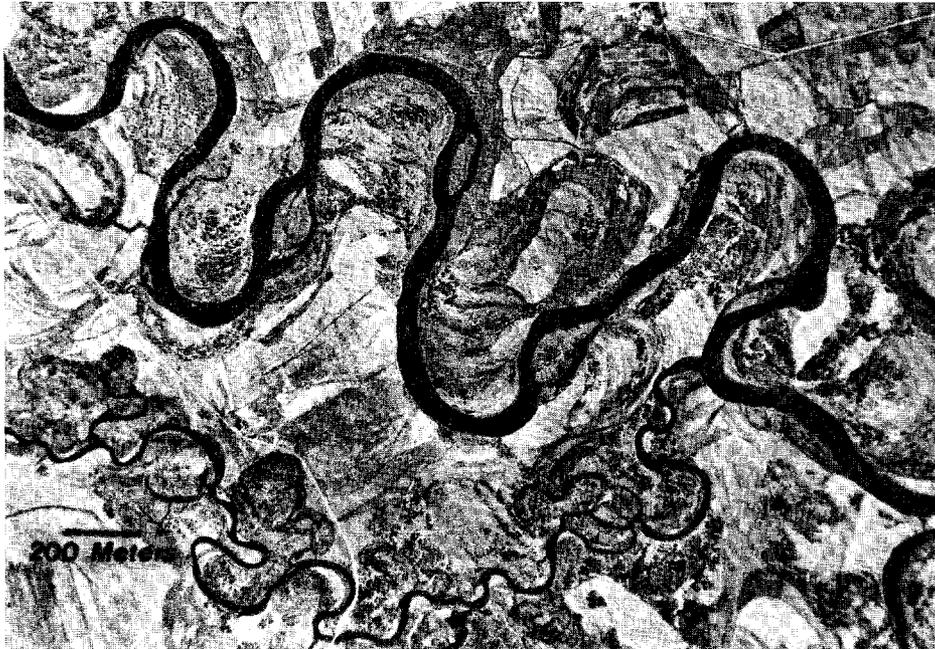
Figure 10. Equiwidth stream, locally anabranching, on a semiarid plain (Henry's Fork near Rexburg, Idaho). The flood plain is marked by many meander scrolls and filled oxbow lakes. The meandering subsidiary channels are anabranches. Point bars are sparsely vegetated, probably because of the dryness of the climate. The stream has an unstable aspect because of the sparse vegetation and the conspicuous meander scrolls, but no lateral erosion could be discerned for the period 1951-66 by comparison of airphotos. (U.S. Dept. of Agriculture photograph, 1951)

Instability of the streambed that results from shift of thalweg (or braids) is, like bank instability, related to stream type and can be assessed from study of airphotos. On equiwidth point-bar streams (figs. 5 through 10), shift of the thalweg during flood is probably minimal. The channel tends to be relatively deep, narrow, and uniform from one place to another. In some reaches of the Red River of the North (a stable equiwidth stream), the thalweg is on the inside of bends, rather than the outside (Welch, 1973, p. 287). In straight reaches, the alternate bars that indicate meandering of the thalweg are rarely present.

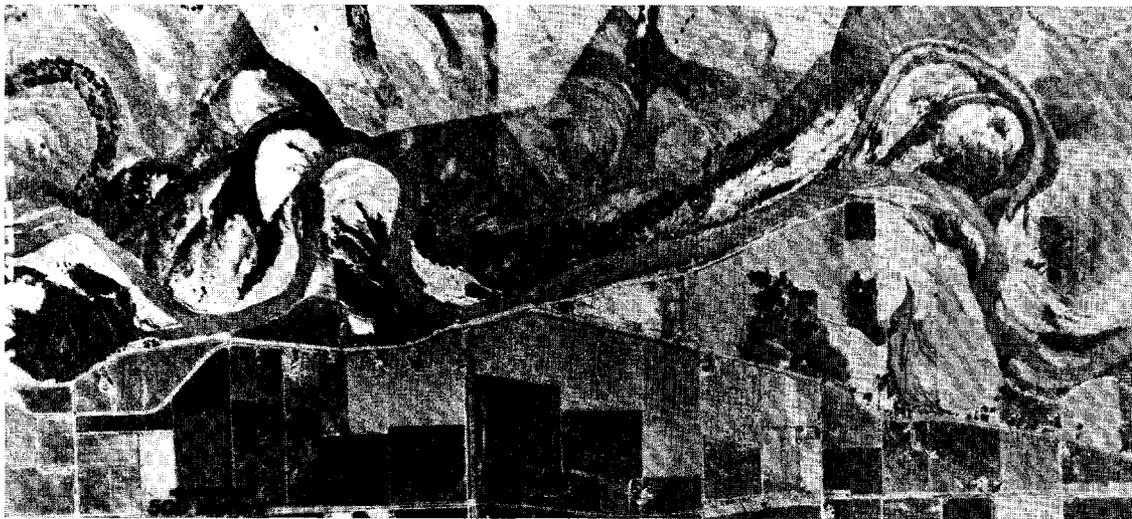
Figure 14. Wide-bend point-bar stream, transitional to a braided point-bar stream (Sacramento River near Butte City, Calif.). Meander scrolls are poorly developed on the wide point bars and lack a regular concentric pattern. At high stages, the flow tends to cut across the necks of meander loops; and loops are cut off by chutes rather than by gradual closure of the neck. The median erosion rate for this reach was about 5 meters per year (0.015 channel width per year) for the period 1947-74. Because of the tendency toward chute cutoffs, bank erosion is difficult to control. (U.S. Dept. of Agriculture photograph, 1970)

A greater shift of the thalweg, both at bends and in nearly straight reaches, can be expected on wide-bend point-bar streams (figs 11 through 15). Flood flow cuts across the ends of the point bars, which are wide and bare at low stage. In straight reaches, alternate bars, visible on airphotos taken at low stage, are commonly present (fig. 13). These alternate bars are significant in the planning of bridges and countermeasures, because they indicate the potential for shift of the thalweg and also for bank erosion at points where the current is deflected against the bank.

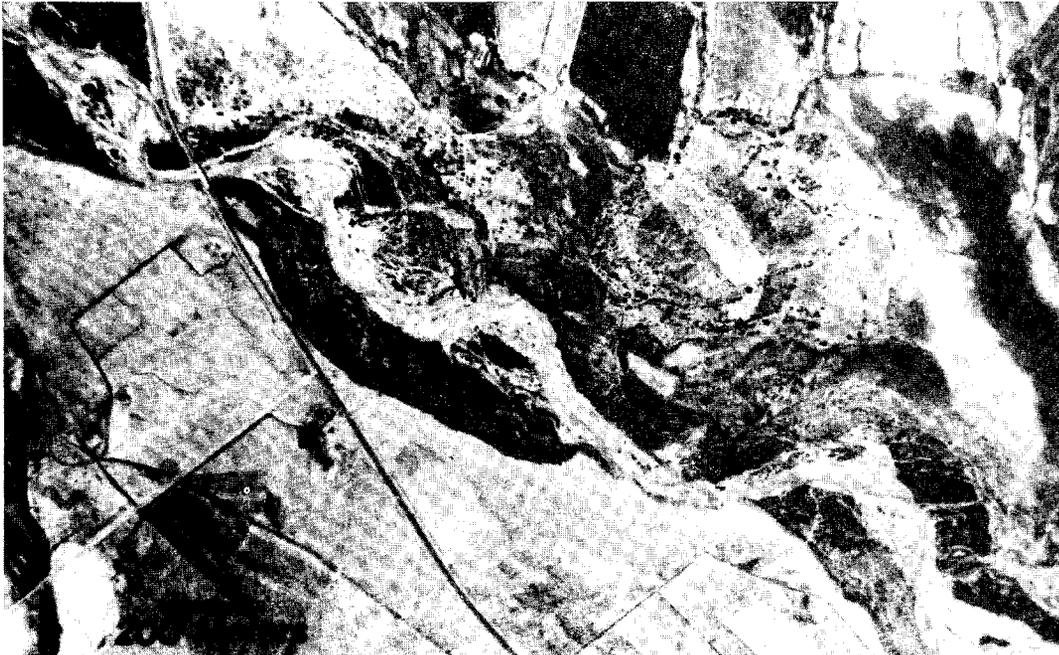
Figure 17. Braided point-bar stream, locally anabranch, in an arid cold-winter climate (Greybull River near Basin, Wyo.). Point bars are marked by a distinctly braided pattern, rather than by concentric scrolls. The meandering thalweg tends to shift during floods and to erode vegetated parts of the flood plain. Anabranches are more transient than for streams in humid regions. During the period 1939-64, the median bank erosion rate was 1.7 meters per year (0.019 channel width per year). (U.S. Dept. of Agriculture photograph, 1939)

The greatest potential for shift of the thalweg is on braided point-bar streams (figs. 16 and 17) and braided streams (figs. 18 and 19). On braided point-bar streams, shift of the thalweg occurs mainly during floods, and the pattern of shift is unpredictable for wide sand-bed channels having a "wandering" thalweg. On braided streams, shift of the thalweg and of braids occurs whenever the flow is sufficient to transport bed material. The pattern of shift is unpredictable, but the depth of natural scour is not likely to be great.

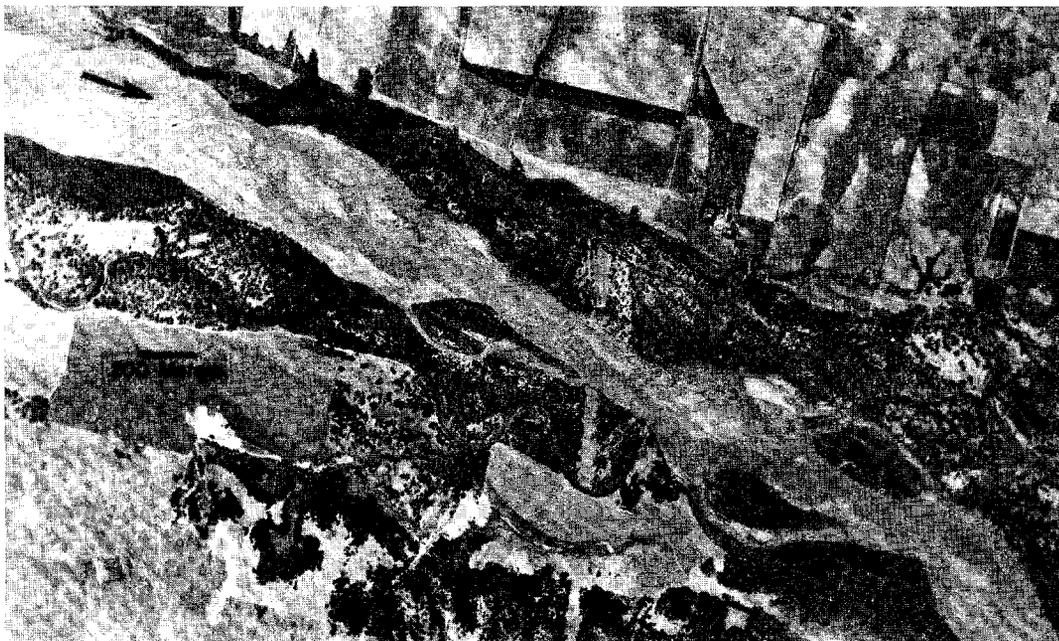
Figure 18. Braided and locally anabranch stream on the semi-arid Great Plains (Niobrara River near Spencer, Nebr.). The flow in the main channel is divided by bars or small islands (vegetated), channel width is variable, and sinuosity is low. Larger islands separate anabranch from the main channel, but an anabranch is usually abandoned after several decades. The bankline is scalloped from place to place, as at upper left, where sinuous braids impinge against it. Although the bed of a braided stream is unstable because of the shift of bars, the bank erosion rate is not necessarily high. For the period 1939-67, the median bank erosion rate for this reach was about 1 meter per year (0.0027 channel width per year). (U.S. Dept. of Agriculture photograph, 1967)

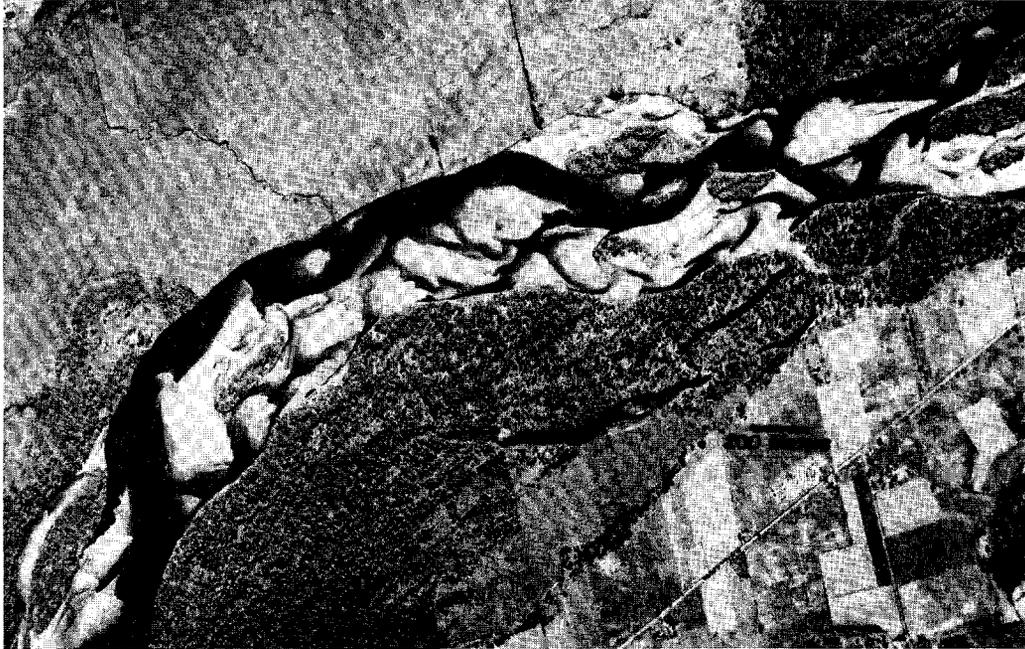
Figure 19. Braided sandbed stream in a humid region (Wisconsin River near Prairie du Sac, Wisc.). Flow within a distinct main channel is divided by sand bars and small vegetated islands. The leaf-like aspect of the bars, as seen on airphotos, is characteristic of sand bars. The bars shift frequently, but the islands (indicated by pointers) showed little change during the period 1940-68. Median bank erosion rate for this period was 0.36 meter per year (0.001 channel width per year). (U.S. Dept. of Agriculture photograph, 1940)

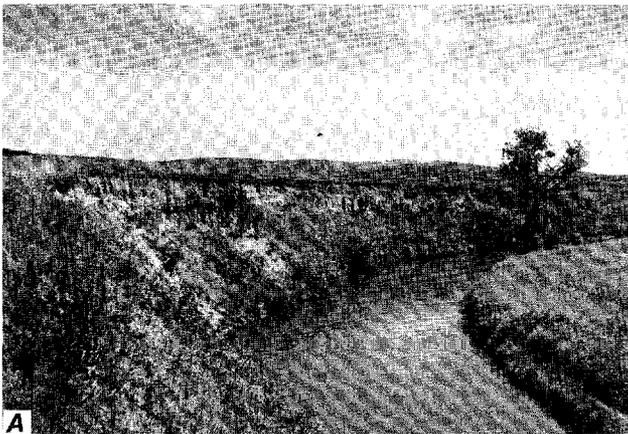
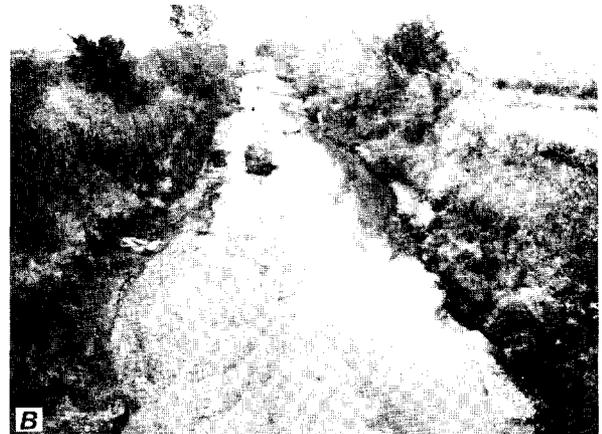
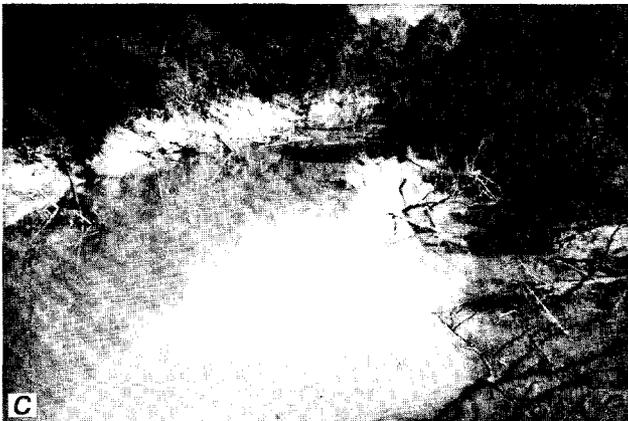
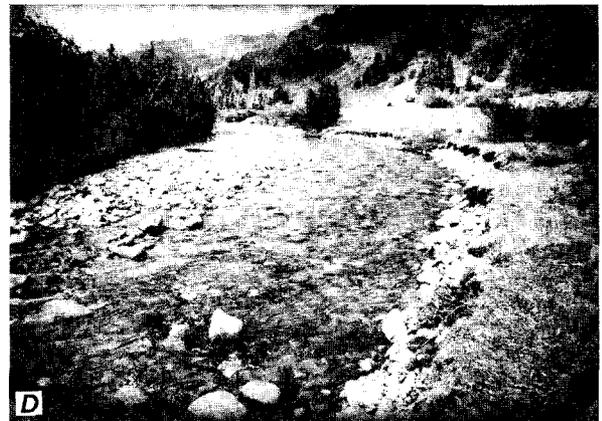
Figure 21. Unstable banks, erosion rate low to moderate. A, South Loup River, Custer Co., Nebr. B, Middle Creek near Lincoln, Nebr. Perennial grasses and small trees on the bank suggest a slow erosion rate, although the bank is steep and not smoothly graded. C, Big Black River near Canton, Miss. D, Dolores River near Lizard Pass, Colo.

Unstable banks, erosion rate slow to moderate-- If a bank is partly graded, the degree of instability is difficult to assess and reliance is placed mainly on vegetation (fig. 21). The grading of a bank typically begins with the accumulation of slumped material at the base (fig. 20E) such that a slope is formed, and progresses by smoothing of the slope and the establishment of vegetation. In figure 21A, the upper bank is locally vertical and the lower graded slope is mostly mantled with grass and weeds. The massive silt in the bank tends to maintain a vertical face and its erosion is probably due more to rainwash than to the stream. The position of the mature cottonwood tree, at far right, and the well vegetated point bar, indicate that the recent erosion rate has been slow. In figure 21B, perennial grasses and small trees on the bank suggest a slow erosion rate, although the bank is steep and not smoothly graded. In figure 21C, the lower bank is bare but partially graded, and the upper bank is densely forested. Bank erosion, and the abundant fallen trees in the channel, are attributed to a recent severe flood, and the bank is likely to be "healed" by regrowth of vegetation. In figure 21D, the low banks consist of boulders

and cobbles overlain by a thick sod mat. In view of the shallow depth and roughness of the channel, the size of the bank materials, and the bank protection afforded by draping of the undercut sod mat, the erosion rate is probably slow.

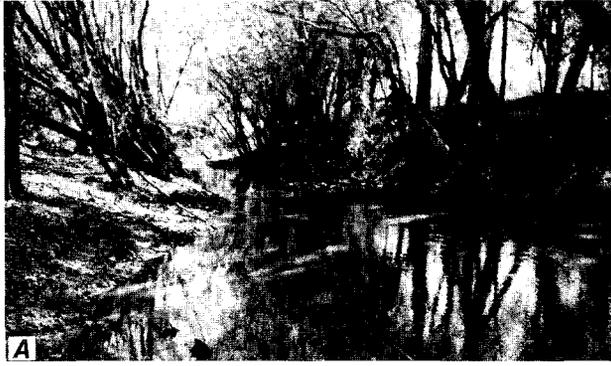
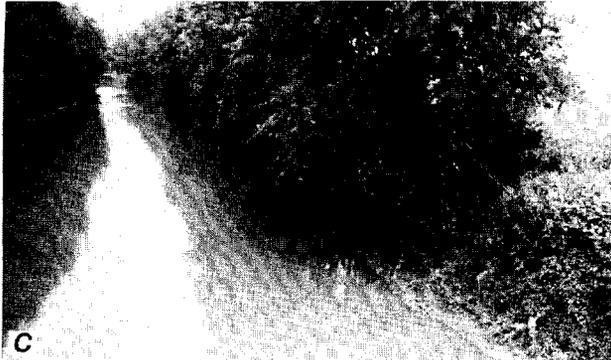
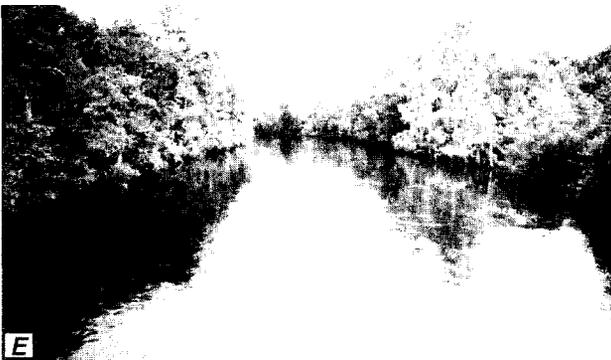
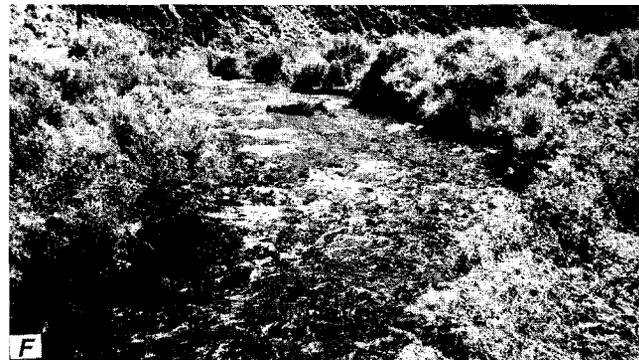
Figure 22. Stable banks, erosion rate very low. A, Rolling Fork near Boston, Ky. Moderately incised channel, mature trees on graded bank. B, Patoka River near Princeton, Ind. Lower bank well graded but unvegetated. C, Blanchard River at Glandorf, Ohio. Lower bank well graded and protected by dense mat of tree roots. D, Fawn River near White Pigeon, Mich. Low banks, densely vegetated. E, Little Pee Dee River at Galivants Ferry, S. Car. F, East Walker River near Bridgeport, Calif. Stream is shallow, high gradient, bed material in the cobble to boulder size range.

Stable banks, erosion rate very slow-- Stable banks tend to be graded to a smooth slope and the slope angle is usually less than about 30 percent (fig. 22). In most regions of the United States, the upper parts of stable banks are vegetated, but the lower part may be bare at normal stage, depending on bank height and flow regimen of the stream. Where banks are low, dense vegetation may extend to the water's edge at normal stage. Mature trees on a graded bank slope are particularly convincing evidence for bank stability. Where banks are high, occasional slumps may occur on even the most stable graded banks. Shallow mountain streams that transport coarse bed material tend to have stable banks.

In figure 22A, the channel is moderately incised, as indicated by the bank height of about 6 meters. The banks attain a slope angle of about 30 percent, but are generally wooded with mature trees. Bank recession occurs locally by slumping, although no slumps are present at this site. In figure 22B, the stable lower bank is well graded but unvegetated. Bank height is about 3 m, and bank slope in the range of 20 to 30 percent. Banks of this type are typical of humid region channels in cohesive alluvium, as are the banks in figure 22C. The stability of

the unvegetated lower bank is increased by a mat of tree roots. The low, well vegetated banks shown in figure 22D are typical of channels in swampy, recently glaciated terrain. On swampy coastal plains, trees tend to grow to the edge of channels (fig. 22E) and the stability of the bankline is indicated by the maturity of the trees. On many mountain streams, as in figure 22F, erosive velocities at the bankline are diminished by the shallow stream depth and the high channel roughness.
